# MAINTENANCE GUIDE CAPACITY

The CapaCITY is extremely robust, thanks to the materials used to construct them. These materials also require a minimum of maintenance, and one annual inspection is generally enough to ensure that they are functioning correctly. VelopA has compiled this maintenance manual for that purpose.

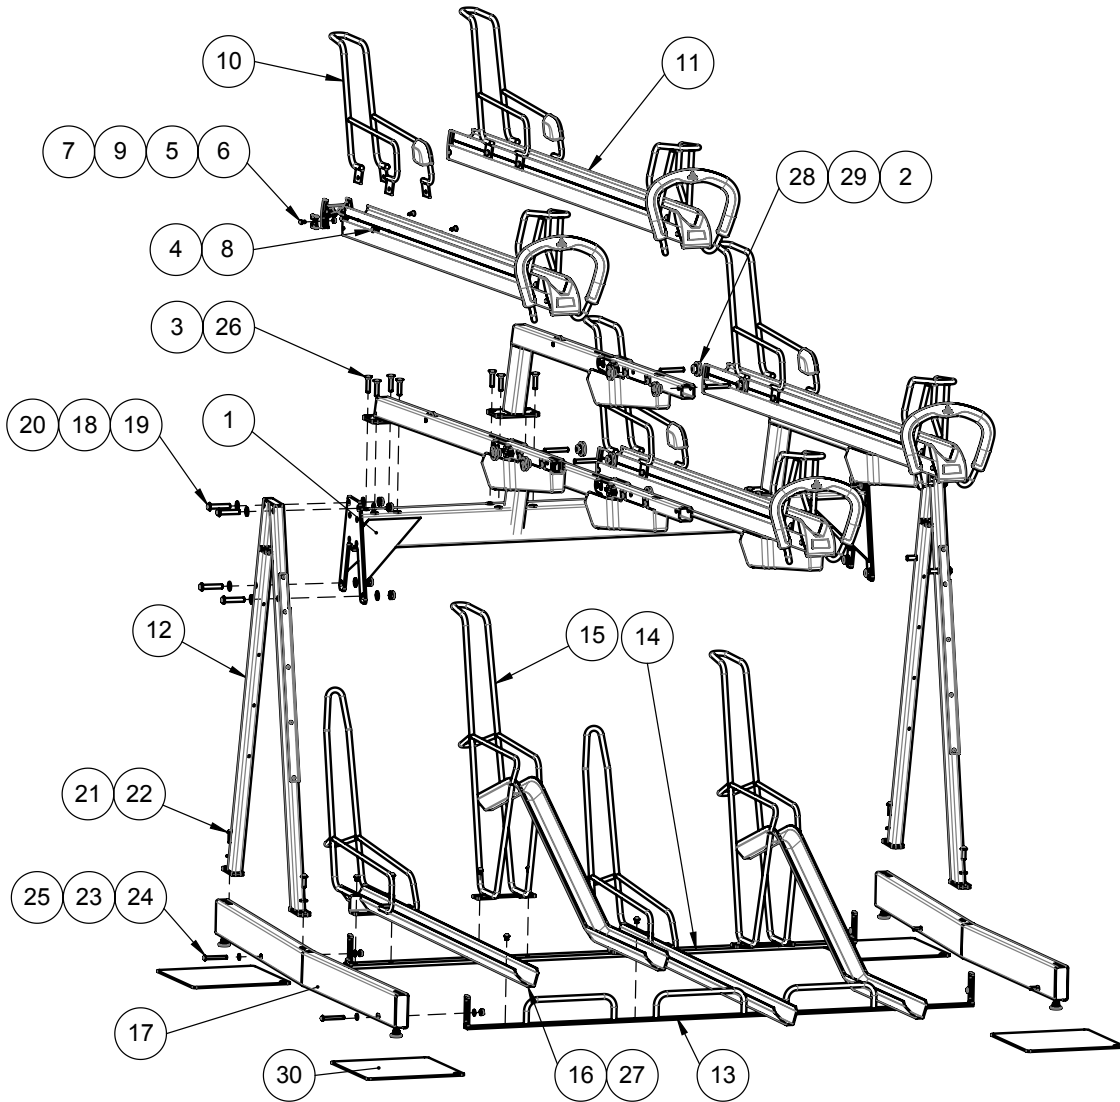
Pcs. no.	Qty.	Art.no.					Weight
1	1	30909112	Ligger 4 plaatsen enkelzijdig	Poutre 4 places unilatérale	Träger 4 Plätze einseitig	Girder C-C 400 - SS 4 pl. - Assembly	20.31
2	3	30909300	Console Premium - Hoog	Console Premium - Haute	Console Premium - Hoch	Console EL Premium - High - Assembly	10.82
3	2	30909310	Console Premium - Laag	Console Premium - Basse	Console Premium - Ebene	Console EL Premium - Low - Assembly	10.03
4	2	30909550	V-rail Premium - Laag	V-rail Premium - Bas	V-rail Premium - Bas	V-rail Premium - Low - Assembly	9.25
5	4	30910920	V-rail - Stop	V-rail - Bouchon	V-rail - Stopfen	V-rail - Stop	0.01
6	4		ISO7380 - M6x12	Bolkop met torx met pin (RVS)	Vis à tête bombée torx avec goupille (Inox)	Flachrundkopf mit torx mit stift (Edelstahl)	Torx button head with pin (SS)
7	4	54320000	DIN 985 - M6	Borgmoer (RVS)	Ecrou bloquant (Inox)	Sicherungsmutter (Edelstahl)	Torque nut (SS)
8	8	DIN 7981C - Ø6,3x16	Torx-schroef met pin (RVS)	Vis de Torx avec goupille (Inox)	Torx-Schraube mit Stift (Edelstahl)	Torx-screw with pin (SS)	0.01

9	1	30910925	V-rail Premium - Achterkap	V-rail Premium - Capot arrière	V-rail Premium - Heckhaube	Assembly - V-rail Premium - End cap	0.04
10	1	30909510	V-rail EL Premium - Voorwielklem	V-rail EL Premium - Pince de roue avant	V-rail EL Premium - Vorderradklemme	Assembly - V-rail EL Premium - Front wheel clamp Assembly	2.61
11	2	30909500	V-rail Premium - Hoog	V-rail Premium - Haute	V-rail Premium - Hoch	V-rail EL Premium - High - Assembly	9.65
12	2	30909201	Portaal - V-stand	Portail - V-stand	Portal - V-stand	Portal - V-stand - Assembly	11.96
13	1	30929810	B-rack - Ligger voorzijde	B-rack - Poutre avant	B-rack - Träger vorderseite	B-rack C-C 400 - Girder front - 4 pl. weldment	3.04
14	1	30909812	B-rack - Ligger midden enkelzijdig	B-rack - Poutre milieu unilatérale	B-rack - Träger mittlerer einseitig	B-rack C-C 400 - Girder middle SS - 4pl. Weldment	7.06
15	2	30909900	V-gutter - Hoog	V-gutter - Haute	V-gutter - Hoch	V-gutter - High - Weldment	8.23

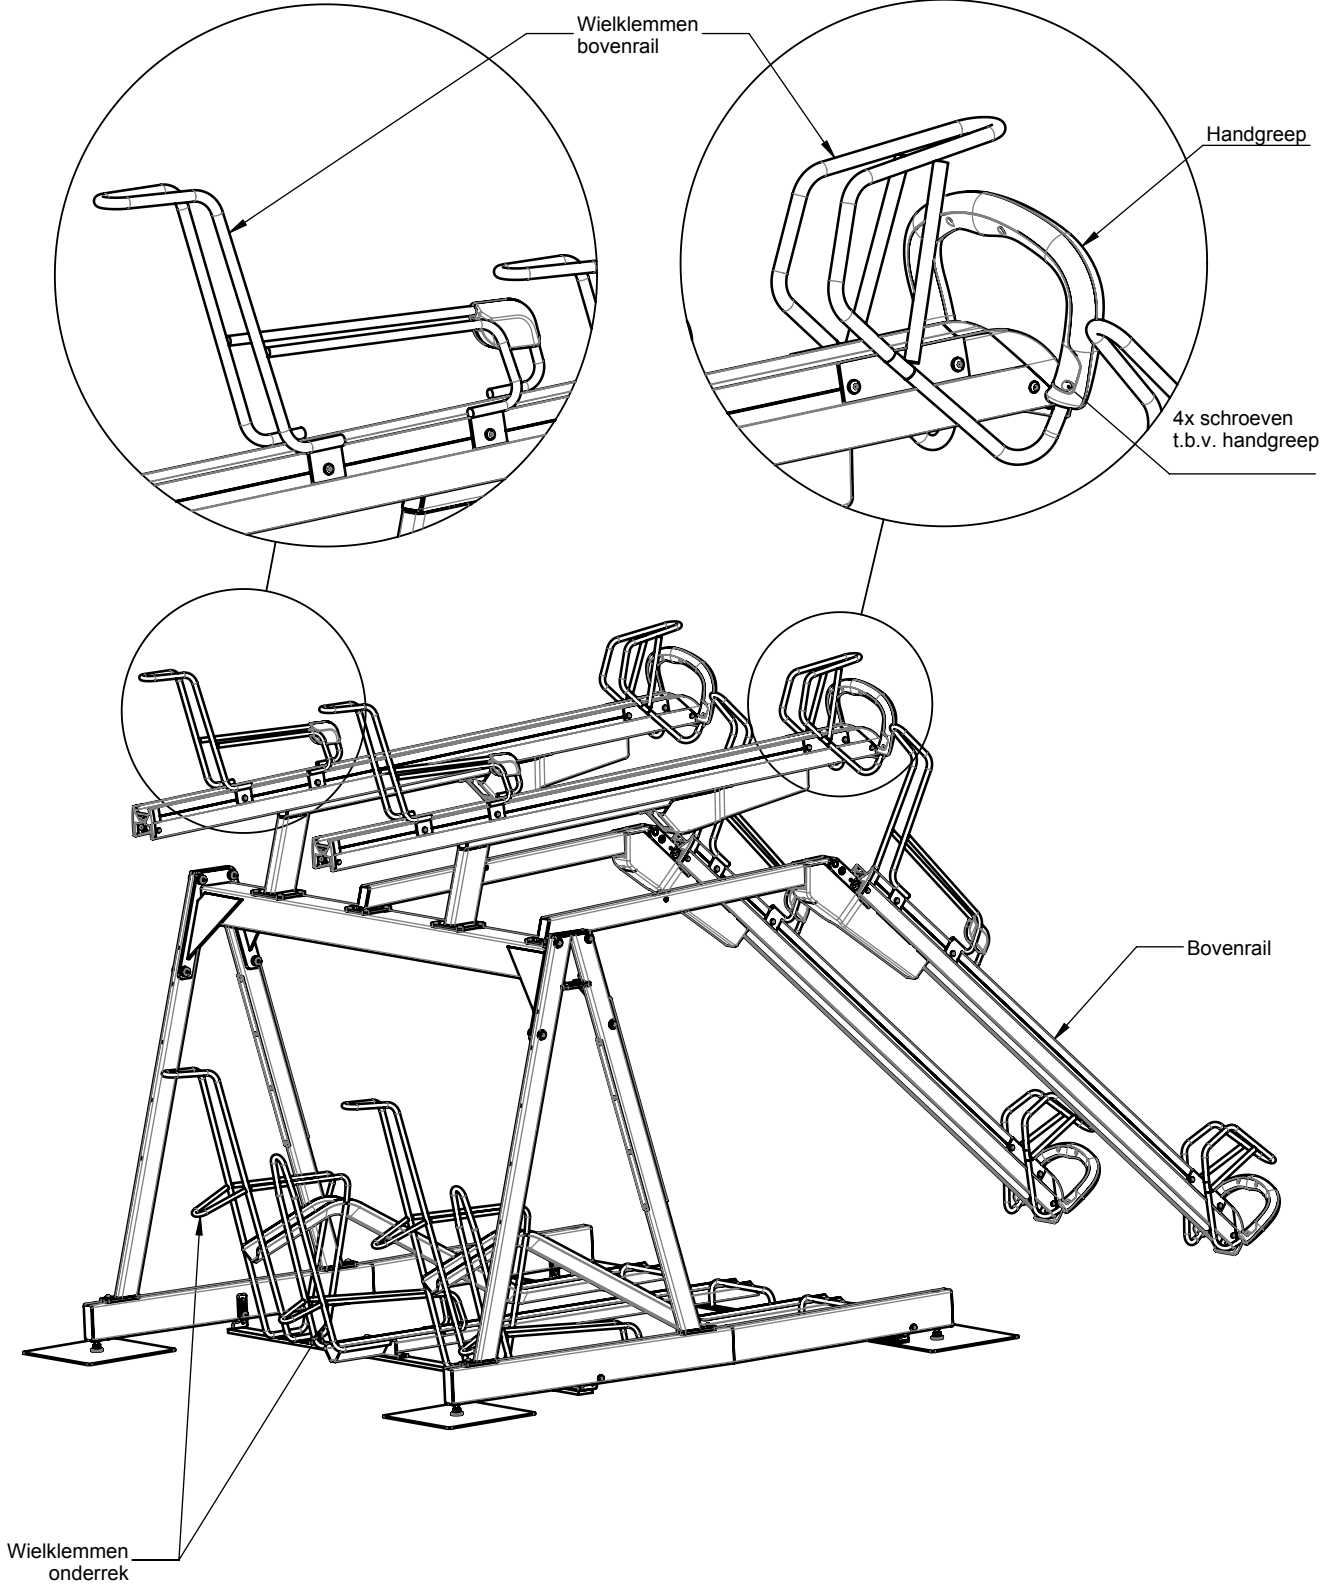
# Drawing 2

**Detail 7**

**Detail 8**

- 3. Check the wheel clamps/locking loops/upper rail:** verify whether any of the components in the lower rack and the upper rail have been bent/damaged. Action: Replace any damaged components if you notice damage that could affect the proper functioning of these elements. See diagram 2, details 7 and 8 (page 7).

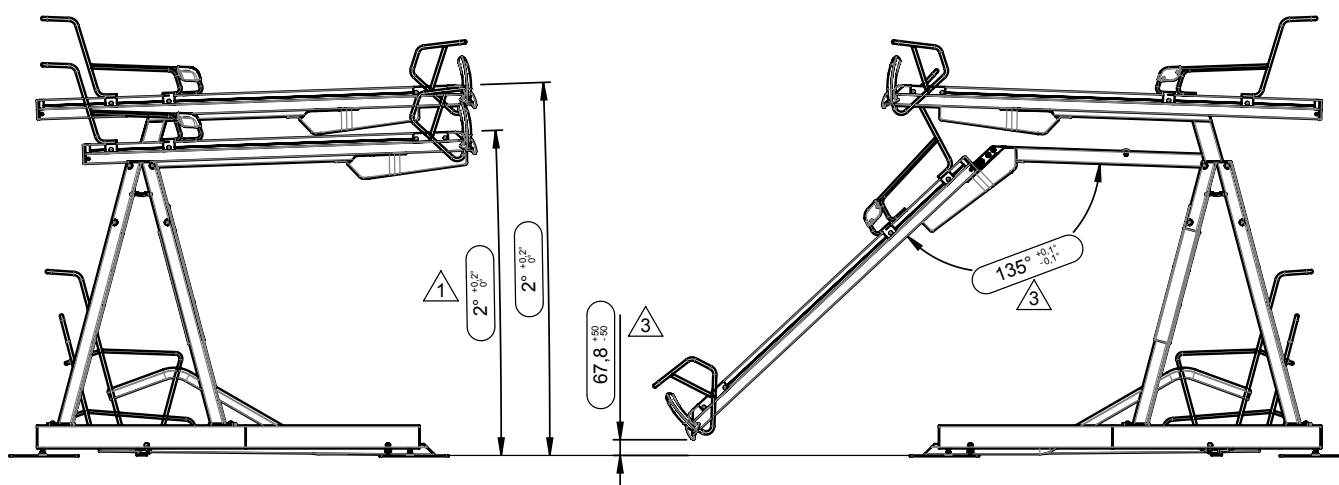
**Laatste controle / Vérification finale / Endkontrolle / Final check**

1. Hoek van 2° is benodigd voor afwatering en dient tevens als uitrolbeveiliging
1. Winkel von 2° wird für die Entwässerung benötigt und dient auch als Rückrollsicherung
1. Un angle de 2° est indispensable pour les écoulements d'eau et le maintien du vélo
1. Angle of 2° is needed for drainage and also serves as roll out security

2. V-rail moet in en uit geschoven worden op de geleiding te controleren
2. V-rail doivent être tirés dans et hors de vérifier la direction
2. V-rail (Schiene) muss eingeschoben und ausgezogen werden, um die Geläufigkeit zu überprüfen
2. V-rail must be pulled in and out to check the guidance
3. Controleer hoek en hoogte voor correcte werking van het scharnier
3. Vérifier l'angle et la hauteur pour le bon fonctionnement de la charnière
3. Überprüfen Sie den Winkel und die Höhe für einen ordnungsgemässen Betrieb des Scharniers
3. Check angle and height for proper operation of the hinge
